检测报告
Test Report

报告编号 A2180054406101001E

样品名称	HT201(外框及挂板) 样一
Sample Name	HT201(外框及挂板) 样一
材质	316 不锈钢
Material	316 不锈钢
样品接收状态	样品表面有划痕
Sample Receiving State	Scratch was found on the sample surface.
样品接收日期	2018.04.20
Sample Received Date	Apr. 20, 2018
样品检测日期	2018.04.20-2018.04.26
Testing Period	Apr. 20, 2018-Apr. 26, 2018

Test Item: Salt spray test

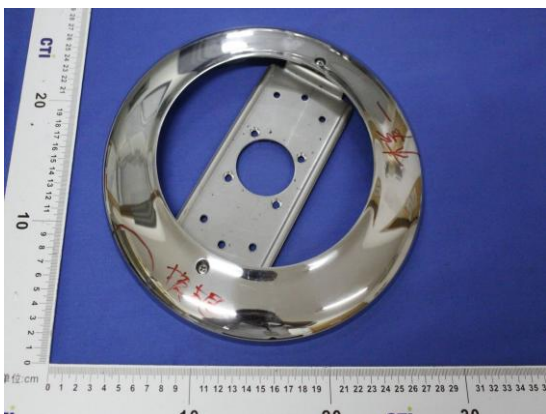
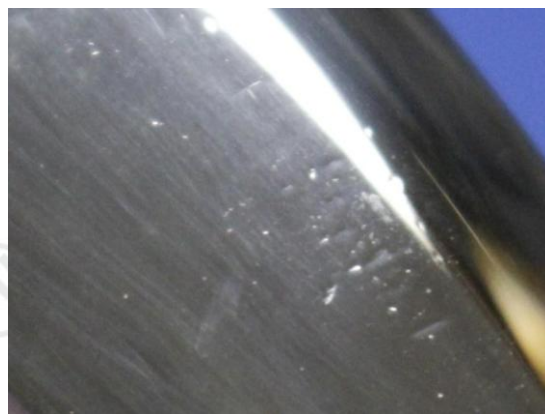
Sample Photo(s)

样品编号 Sample No.	样品名称 Sample Name	材质 Material	样品数量 Quantity
A2180054406101001	HT201(外框及挂板) 样一	316 不锈钢	1pc
	HT201(外框及挂板) 样一	316 不锈钢

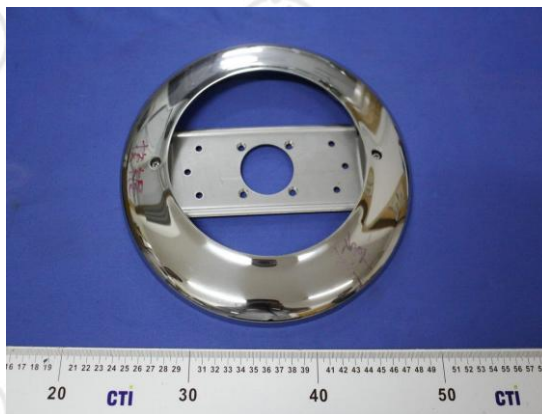
Sample Photo(s) after the test

样品编号 Sample No.	测试结果（目视检查） Test result(s) (Visual inspection)
A2180054406101001	样品表面无腐蚀 No corrosion was found on the sample surface.

试验箱温度：35℃

溶液浓度：5%NaCl（质量比）

Test duration: 72 hours
